FATIGUE INITIATION STUDY OF INVESTMENT CAST Ti-6Al-4V ALLOY

D. S. Hurd and E. W. Lee

Naval Air Warfare Center, Aircraft Division
Patuxent River, Maryland

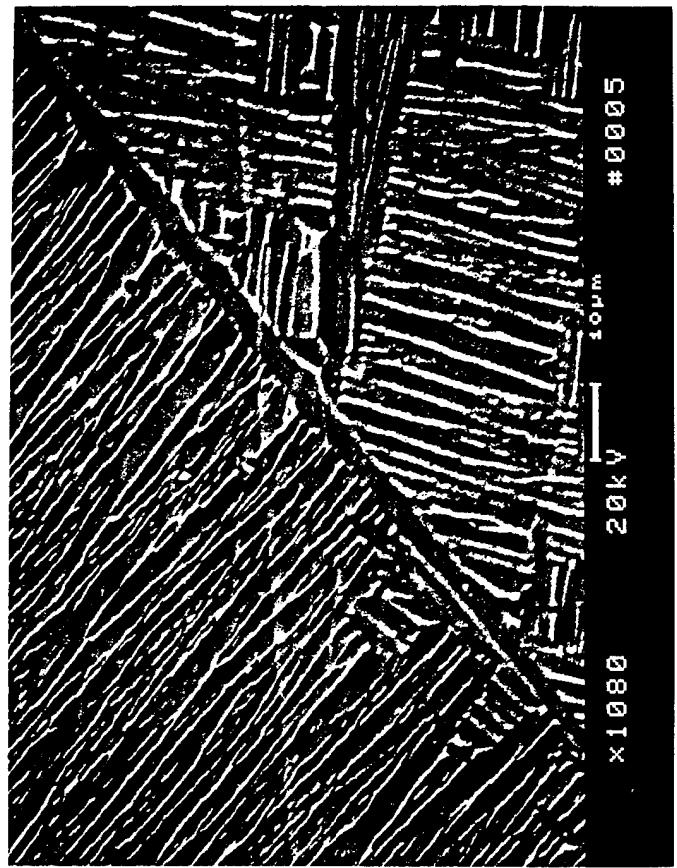
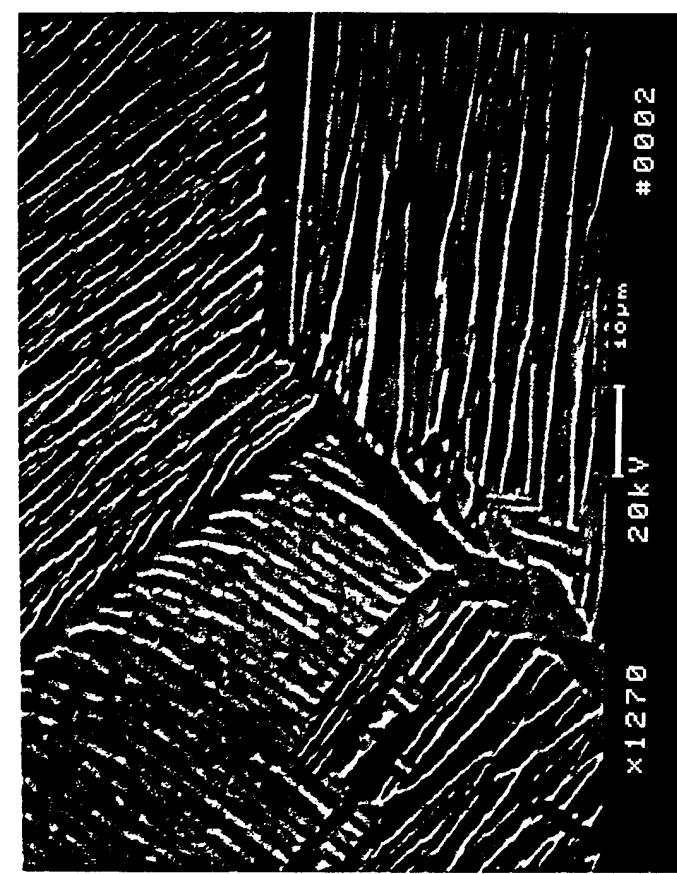
WIDMANSTÄTTEN MICROSTRUCTURE

- Prior- β grain triple point visible in photo on left.
- Thicker α -platelets (\sim 1-2 μ) separated by thin β -platelets (\sim 0.5 μ).
- Microcrack initiating/arresting at prior- β grain boundary.

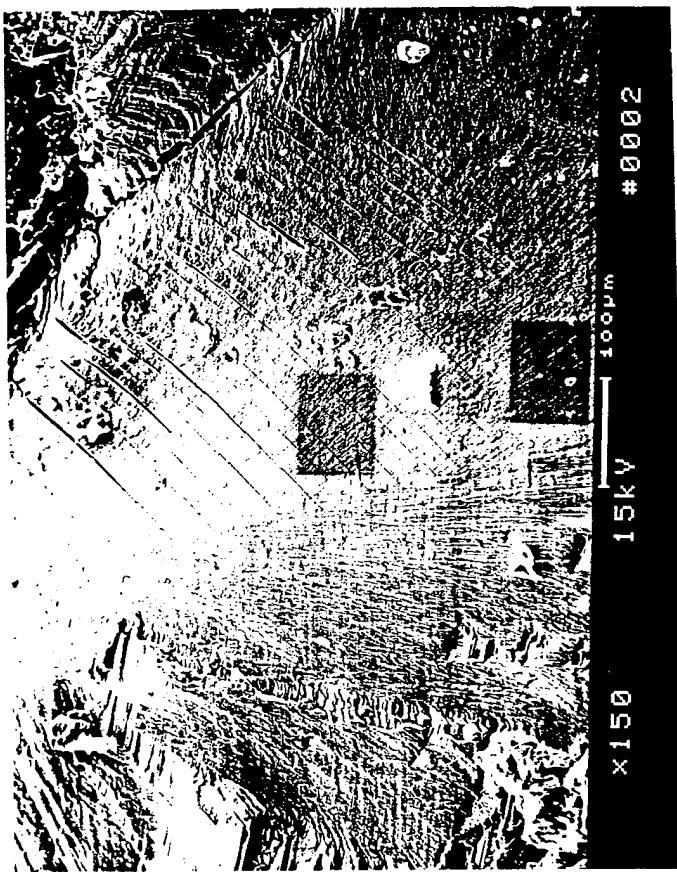
TYPICAL SHEAR INITIATION FACETS

Max. dimension ~ 0.5 mm

Max. dimension ~ 1.3 mm

- Note flat and shiny appearance of facets.
- Grain boundary cracking often evident along boundary of facets.

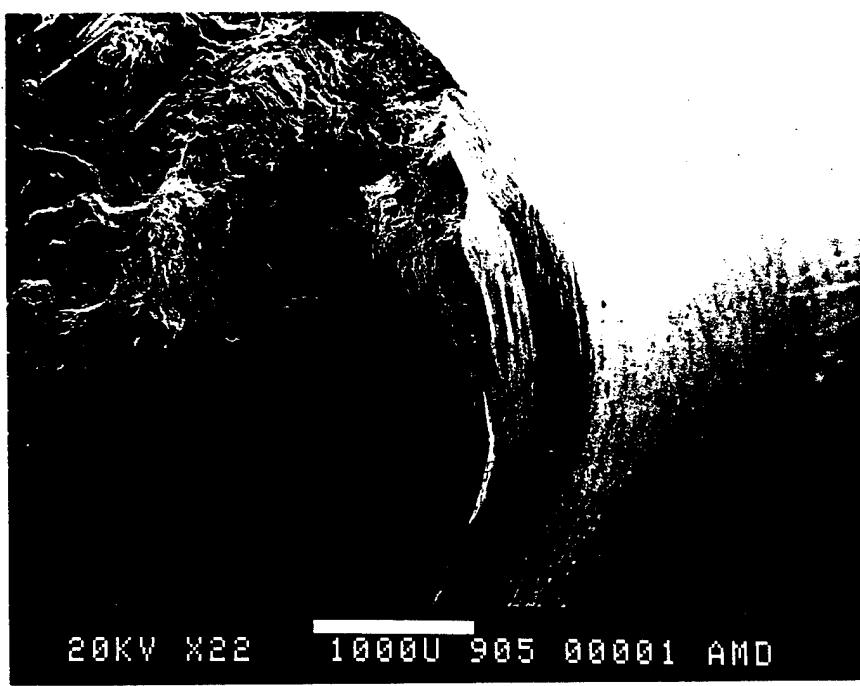
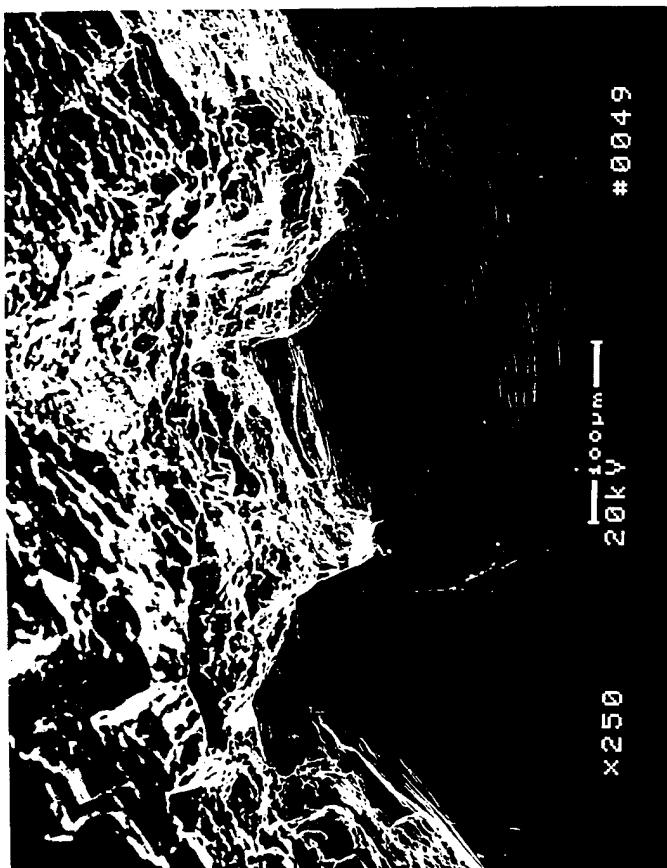
MAGNIFIED VIEW OF SHEAR FACET

- Note regularly-spaced, extensive secondary cracking on facet.
- Prior- β grain boundary cracking also evident.
- Crack appears to radiate from a point.

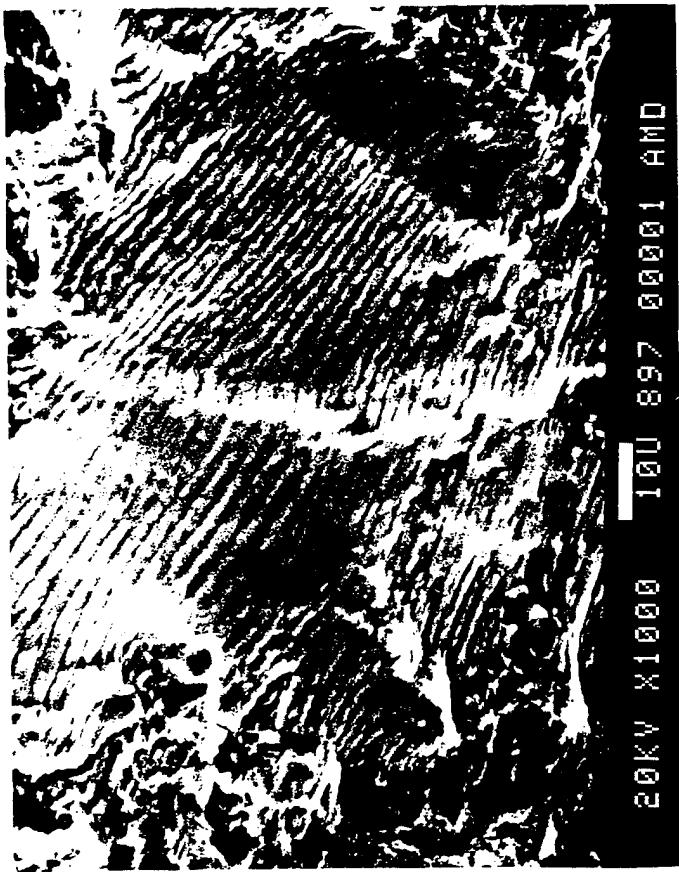
SURFACE AT FINAL FRACTURE

- Extensive deformation at surface characteristic of final fracture.
- Surface at initiation site relatively undeformed (except at very hi-mag)

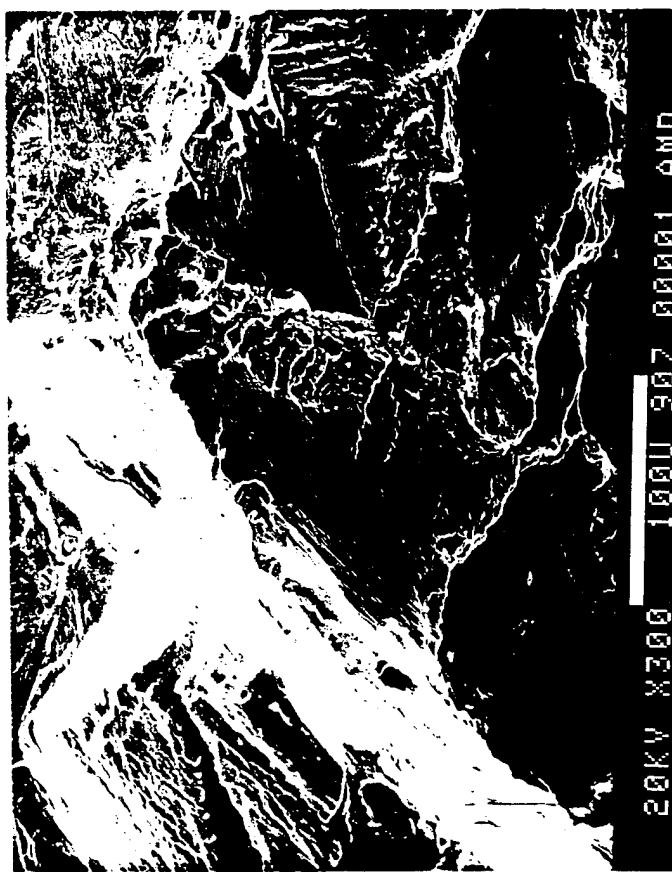
STRIATED PROPAGATION

Striation density $\sim 600/\text{mm}$

- Just beyond initiation facet, striated propagation occurs.
- Striations are oriented differently in neighboring grains and colonies.
